# Overview & Level 1 Fish Habitat Assessment and Enhancement Opportunities

Brooklyn Creek Watershed,  
Comox, BC

Prepared for  
Brooklyn Creek Watershed Society

Final Draft: April 1, 2022

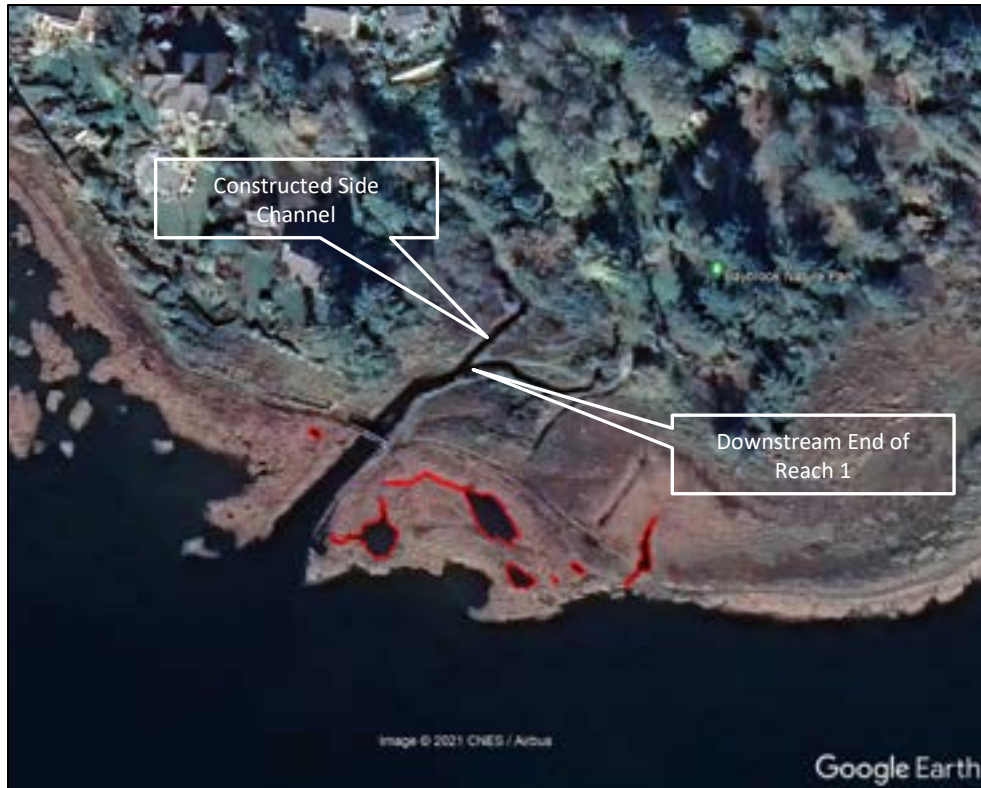
There are several depressions in the low salt marsh (Photo 2), where water is retained during low tide, shown with red outlines in Figure 6. These areas provide habitat for fishes and other aquatic organisms during the low tide cycle. Based on aerial imagery from 2021 (Google Earth 2021), the approximate total area of these depressions is 360 m<sup>2</sup>.

**Figure 6. Depressions (outlined in red) in the low salt marsh habitat at the outlet of Brooklyn Creek – these retain water during low tide (Google Earth 2021).**

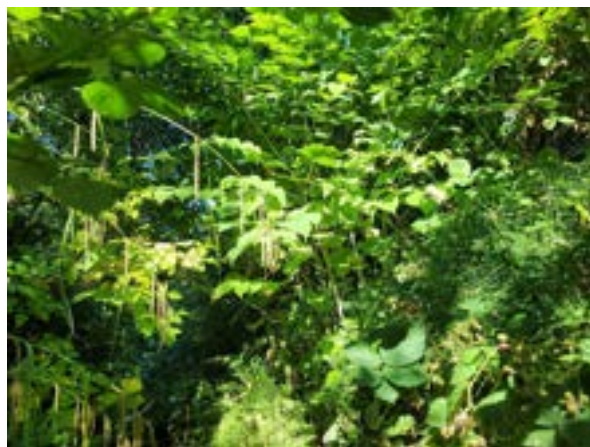
Photo 15. Large patch of Japanese knotweed along right bank of constructed side channel, near upstream end where it connects to the mainstem (above; Aug. 12, 2021).

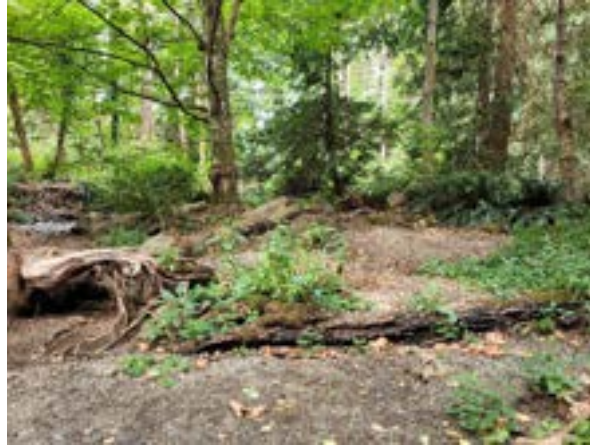
**Photos 34.** Denuded area along right bank at km 1+690 where native planting should be conducted (above; Aug. 20, 2021).

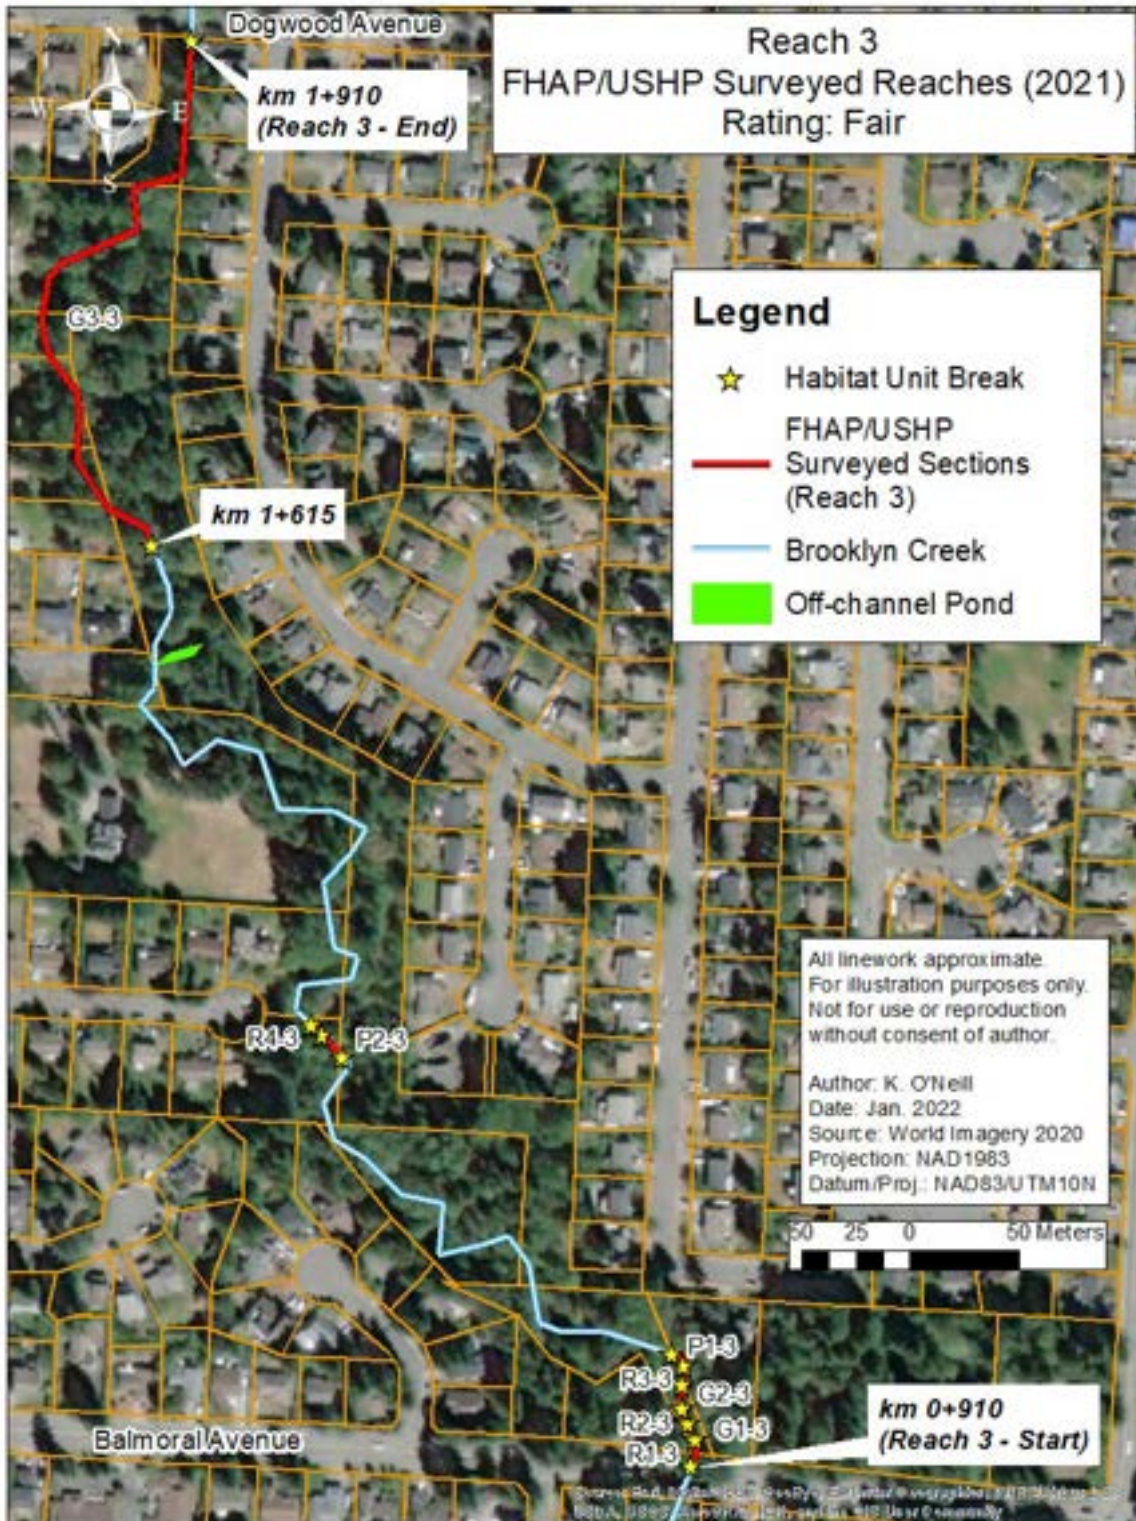
Habitat Parameter	Reach 3	Ratings	
		Score	Rating
% Pool Area	n/a	n/a	-
LWD/BFW	0.31	5	Poor
% Stream Cover	14.44	3	Fair
Average % Fines	6.67	1	Good
Average % Gravel	57.22	1	Good
% Wetted Area	56.24	5	Poor
% Crown Cover	52.22	1	Good
Erosion Sites	n/a	n/a	-
Obstructions	n/a	n/a	-
Alteration Sites	n/a	n/a	-
<b>Totals</b>		<b>16</b>	<b>Fair</b>

Figure 9. Modified FHAP/USHP Surveyed Habitat Units in Reach 3. Note: Overall reach is rated as fair based on FHAP/USHP measurements and visual assessments, however the upper 293 m section of the reach (HU G3-3) is very different and is considered poor for fish habitat.

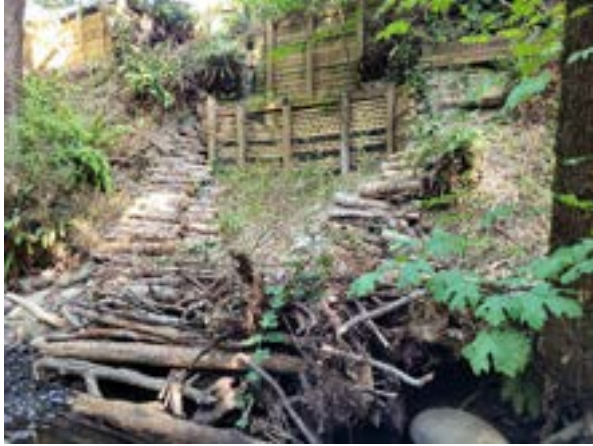
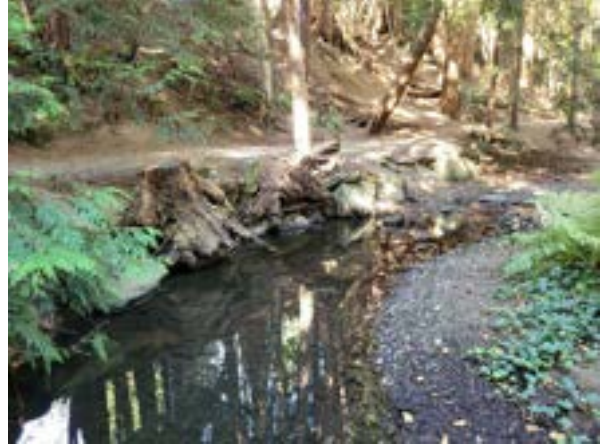
Photos 35 & 36. Retaining wall constructed by property owner along eroding left bank in HU G2-3 (above left; Aug. 20, 2021). Riprap armoured right bank preventing pedestrian path from eroding into stream in lower portion of Reach 3. Steep ravine bank to the west of the walking path. Recommend riparian planting between riprap wall and pedestrian path. Dense English ivy along left bank (above right; Aug. 25, 2021).

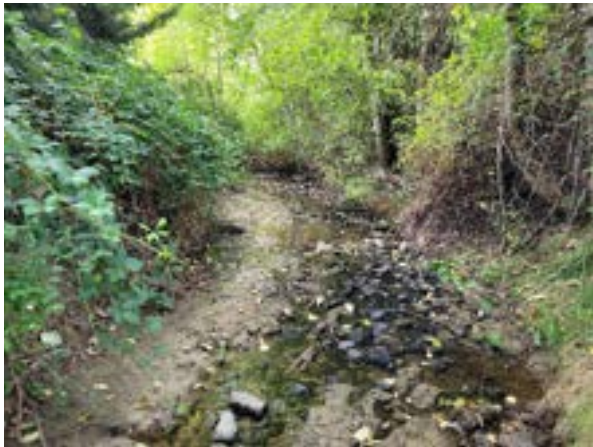
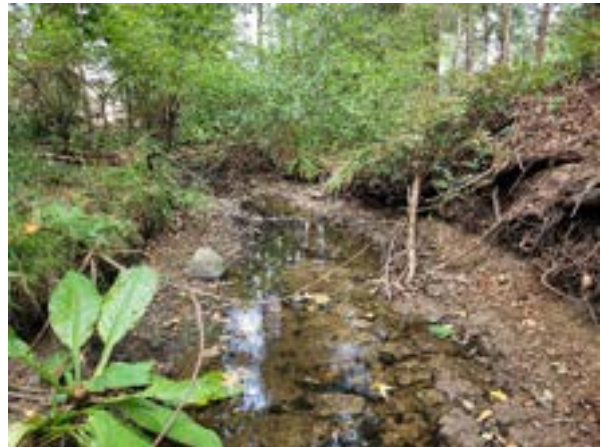
Photos 37 & 38. Eroded hardpan substrate and banks in upper portion of Reach 3 (above left; Aug. 25, 2021). Cutbanks and exposed roots in upper portion of Reach 3 (above right; Aug. 25, 2021).

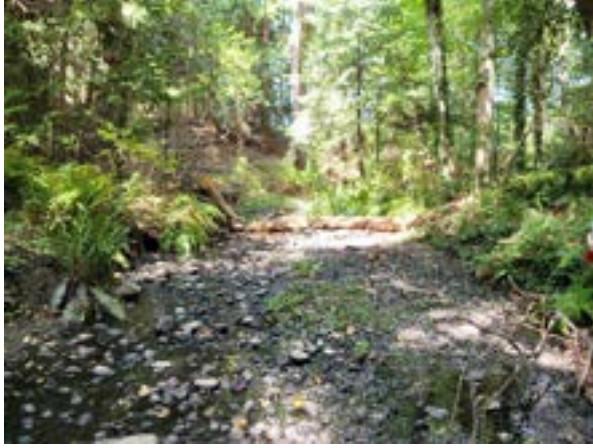
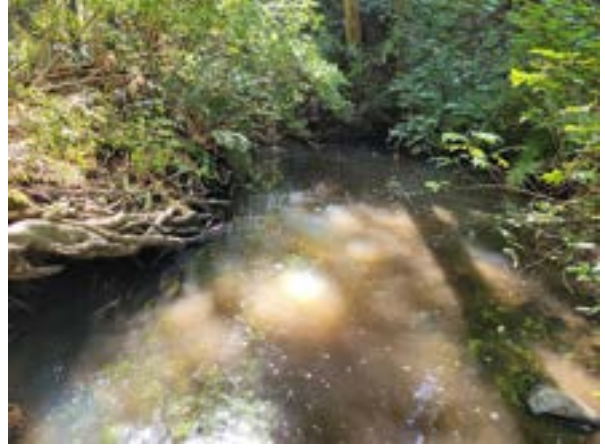
Photos 41 & 42. Gravel bar with potential spawning opportunities at approximately km 1+175 (above left; Aug. 25, 2021). Deep pool habitat with overhanging vegetation and cutbanks providing cover for salmonids at approximately km 1+160. Juvenile cutthroat trout and coho observed in this pool (above right; Aug. 25, 2021).

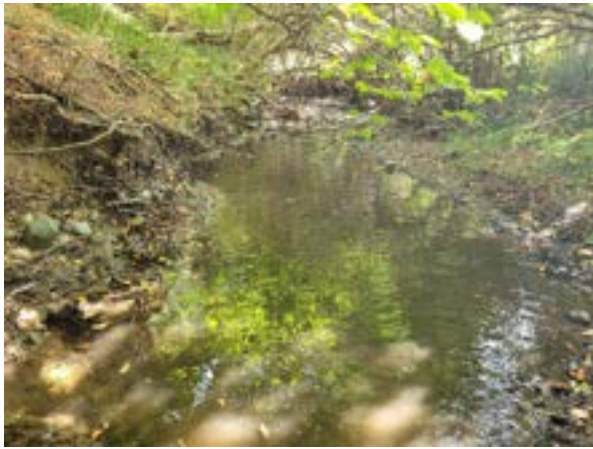
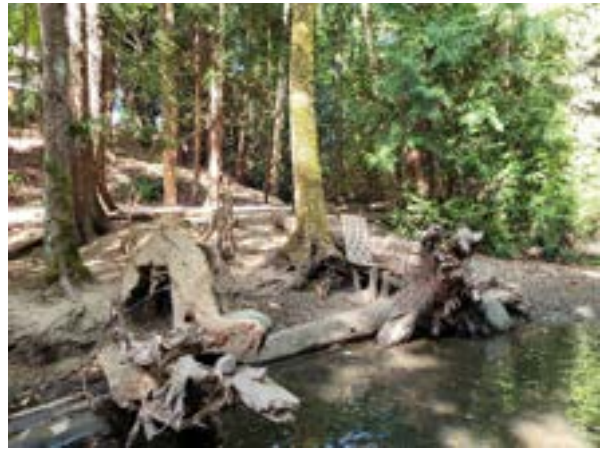
Photos 43 & 44. Last pool observed in upstream section of reach (at km 1+615); no pools or riffles upstream to Dogwood Avenue. Pool lacks hydraulic and habitat complexity and substrates and banks are composed of eroding hardpan. (above left; Aug. 25, 2021). Denuded area to be planted and fenced along right bank at km 1+060 (above right; Aug. 25, 2021).

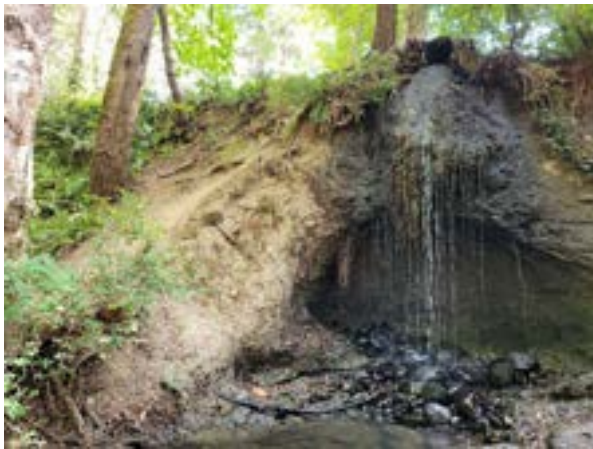
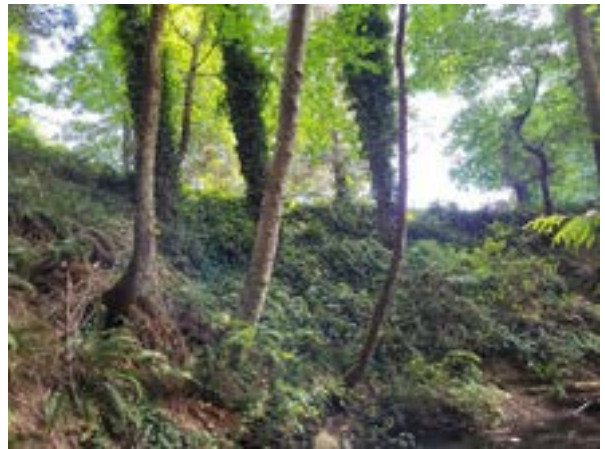
Photos 45 & 46. Artificial waterfall feature on left bank from drainage pipe outletting at km 1+060 (above left; Aug. 25, 2021). English ivy covering steep left bank and climbing up trees between km 1+080 – 1+088 (above right; Aug. 25, 2021).

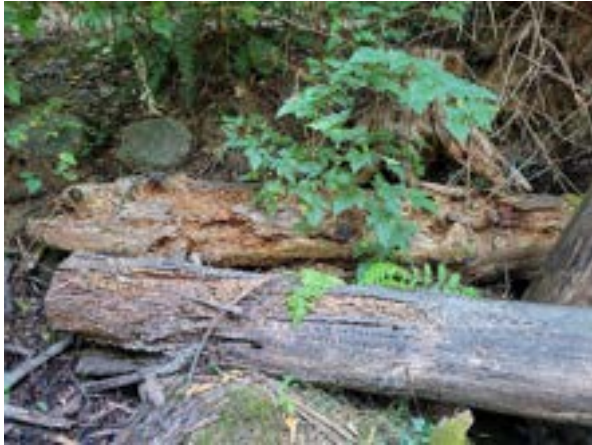
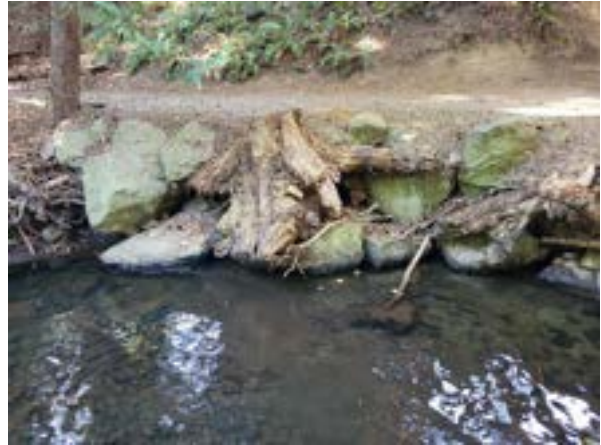
Photos 49 & 50. LWD structure along right bank at km 1+030 beginning to rot – soil could be used to backfill bank behind structure to further anchor it into bank (above left; Aug. 25, 2021). LWD structure holding up right bank and above low water level at km 1+037 – could install additional LWD structures closer to low water mark (above right; Aug. 25, 2021).

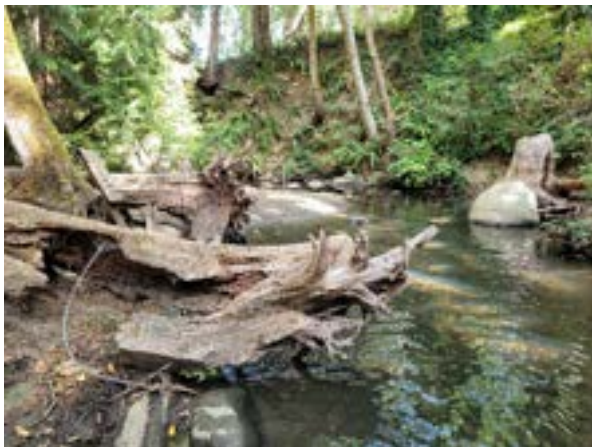
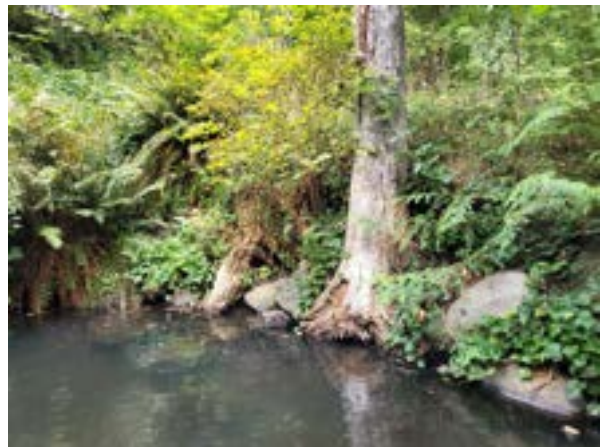
Photos 51 & 52. LWD structure along right bank at km 1+060 beginning to rot – could be supplemented with an additional stump or root wad (above left; Aug. 25, 2021). Rotting LWD structure along right bank in pool at km 1+290 – good candidate pool for larger LWD (above right; Aug. 25, 2021).

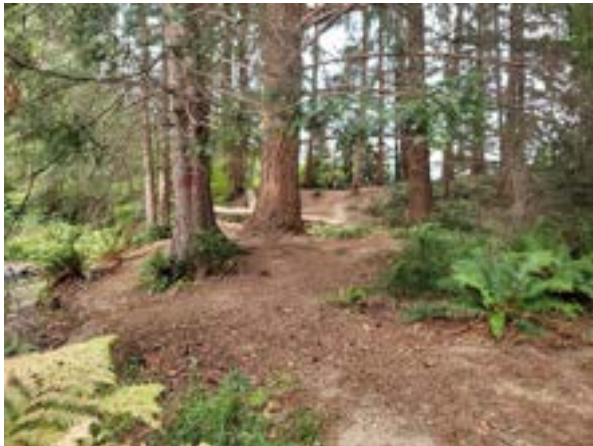
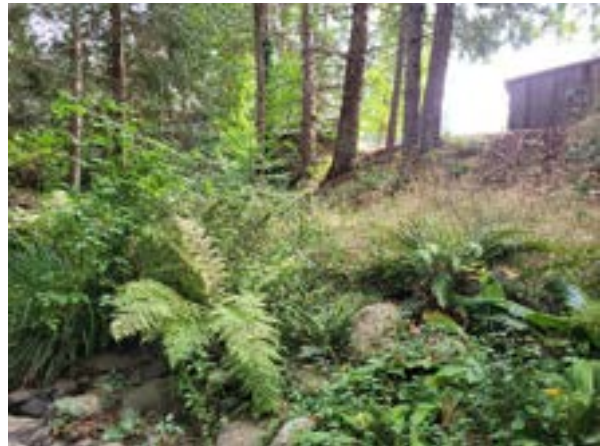
**Photos 55 & 56. Denuded left bank lacking understory plants between km 1+422 and 1+455 – recommend planting and fencing (above left; Aug. 25, 2021). Grassy area between km 1+465 and km 1+491 that should be planted with taller shrubs and trees to enhance riparian area (above right; Aug. 25, 2021).**

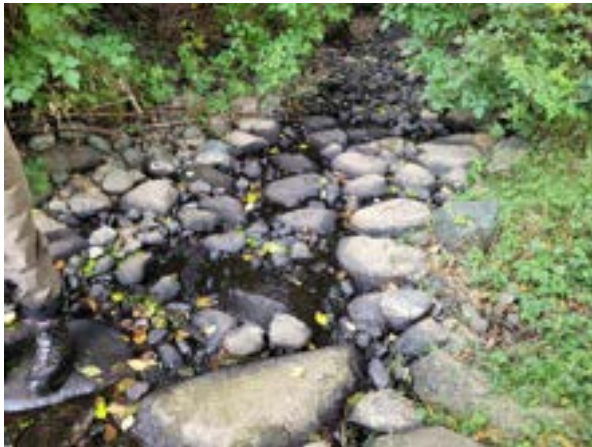
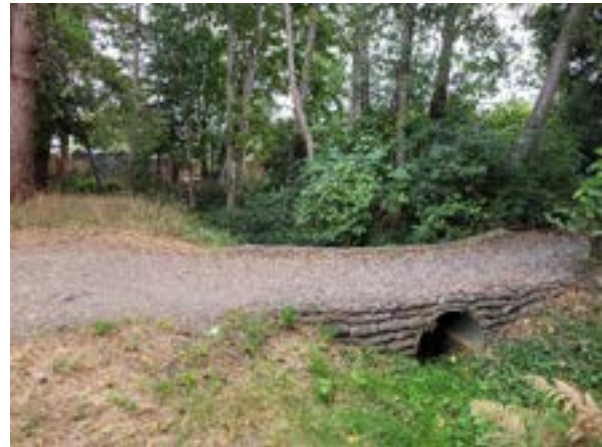
Photos 70 & 71. CR4.1 (HU R1-4) looking downstream; in good condition (above left; Aug. 26, 2021). Straightened channel between pedestrian bridge and Noel Avenue filled with in-stream vegetation (above left; Aug. 26, 2021). Constructed channel connecting the off-channel pond to Brooklyn Creek during high flow events (above right; Aug. 26, 2021).

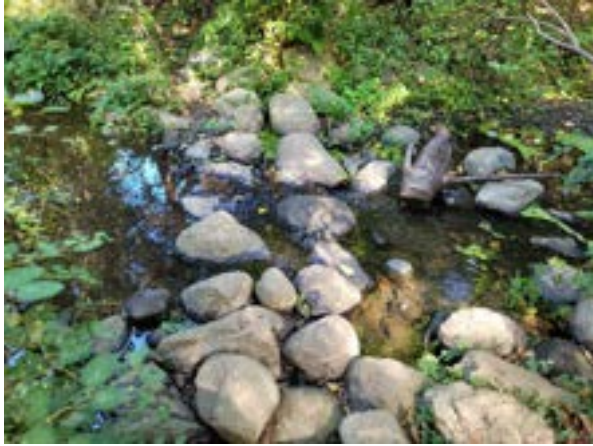
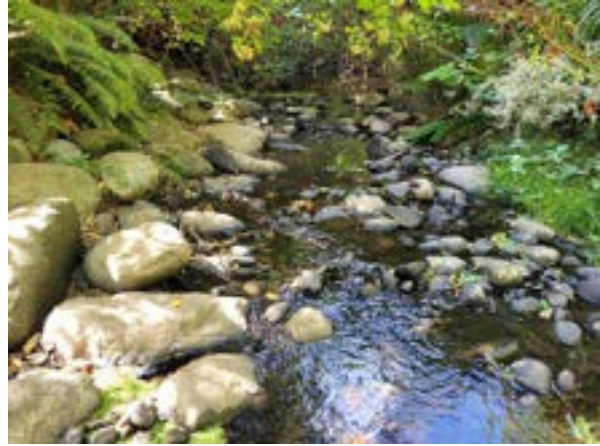
Photos 78 & 79. Constructed riffles in the Salish Park section of Reach 5 – both in good condition with no maintenance required (above left and right; Sept. 2, 2021).

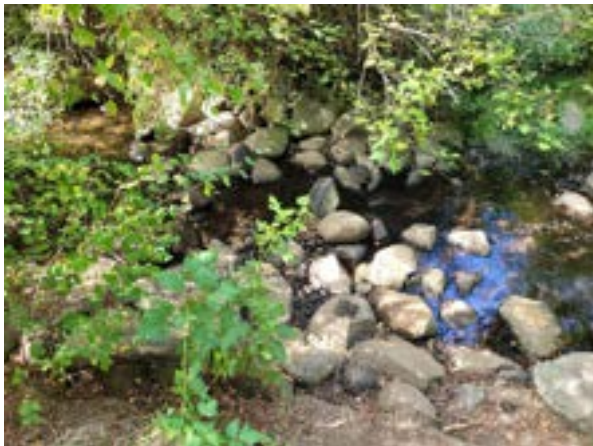
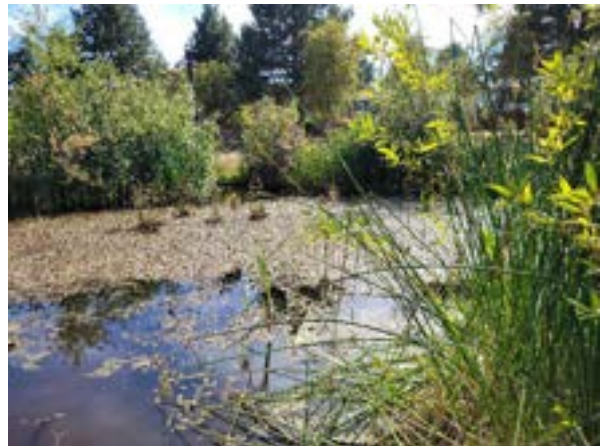
Photos 80 & 81. Constructed riffle in the Salish Park section of Reach 5 –in good condition with no maintenance required (above left; Sept. 2, 2021). Stormwater detention pond in Salish Park functioning well (above right; Sept. 2, 2021).

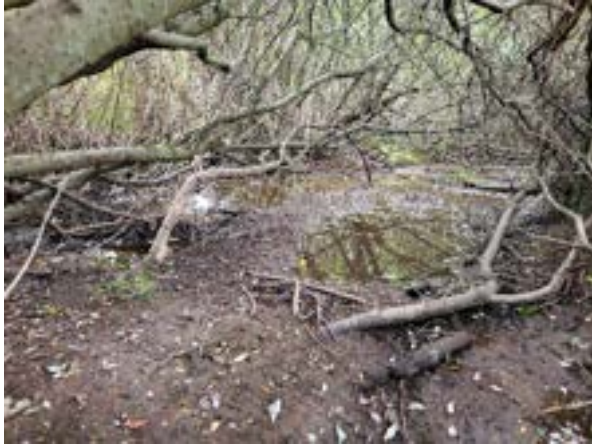
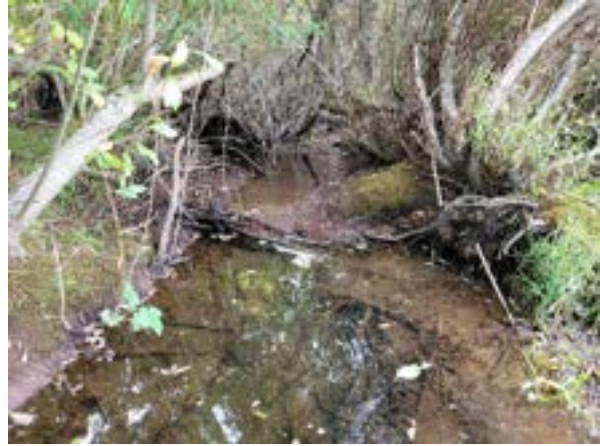
Photos 88 & 89. Willows growing in centre of channel at approximately km 4+350 are causing channel to braid, creating isolated shallow depressions of water adjacent to the main channel; looking upstream (above left; Aug. 26, 2021). Plunge pool immediately downstream of braided portion of channel where willows are growing, looking upstream. Juvenile cutthroat trout observed in pool on Aug. 26, 2021. Pool has good overhanging and riparian cover (above right; Aug. 26, 2021).
