## Post Construction Environmental Monitoring Report

Brooklyn Creek (2010) Channel  
Enhancement Project

Town of Comox

km 1+100 to 1+460  
Brooklyn Creek, Comox, BC

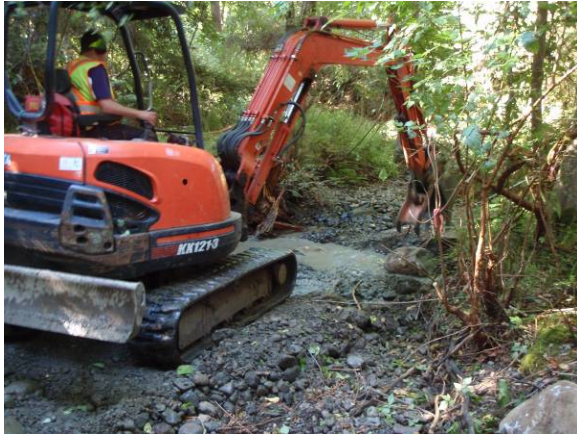
**Photo 1. Construction of rock riffle using small excavator positioned in stream channel. (Aug 24, 2010).**

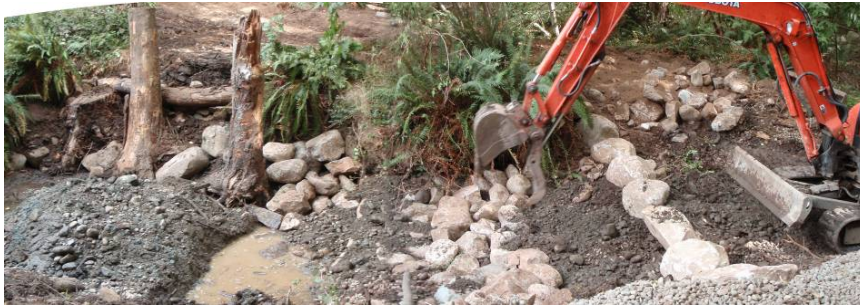
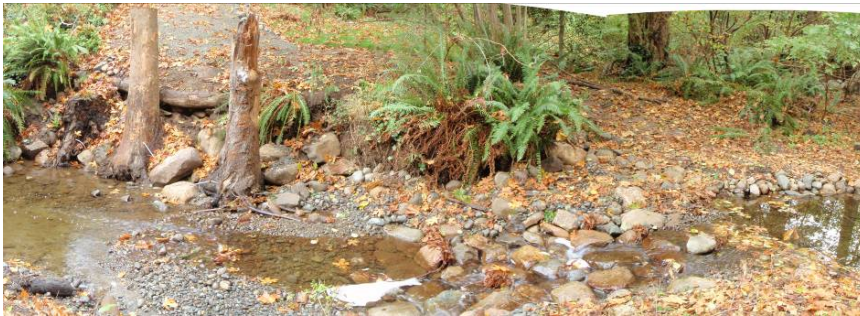
**Photo 2 & 3. Installation of riffle and LWD features at km 1+200 during (top) and after construction (bottom) on Aug 19 & Oct 14 respectively.**

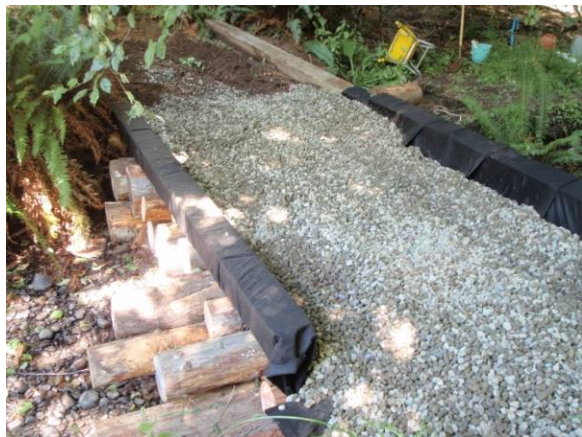
**Photo 4. Temporary log bridge used at km 1+200 showing gravel reserved during bridge decommissioning for riffle construction. (Aug. 9 2010).**

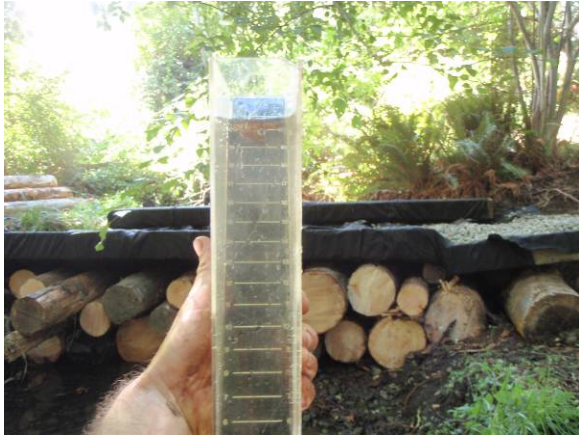
**Photo 5. Turbidity measurement taken at temporary crossing during bridge construction. (Aug 9, 2010).**

installation of spawning platforms and rock riffles the wash down water was intercepted with pumps and discharged to biophysical BMPs including natural depressions in the adjacent forest. Turbidity levels were measured during construction to ensure minimum water quality standards were complied to (Photo 5). Site reclamation following construction involved installation of native rooted stock and live willow stakes as well as placement of recumbent course woody debris and a vertical snag for the benefit of wildlife (Photos 6 & 7).

No unexpected disturbances were incurred on riparian or fish habitat as a result of ISR work. Disturbances to the channel banks and streambed were minimized during machine crossings and material distribution by constructing temporary crossings or protecting the banks with logs (Photo 8). While water quality measurements collected throughout construction showed that turbidity temporarily increased as a result of ISR work the levels remained within acceptable limits.

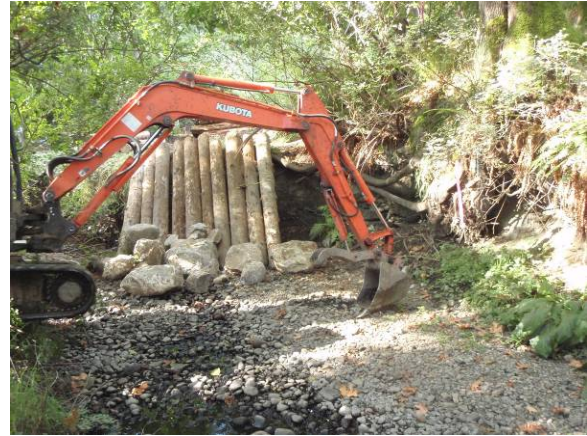
**Photo 8. Temporary bank protection using logs to reduce impact of boulders delivered by bobcat to riffle construction site (Aug 17, 2010).**

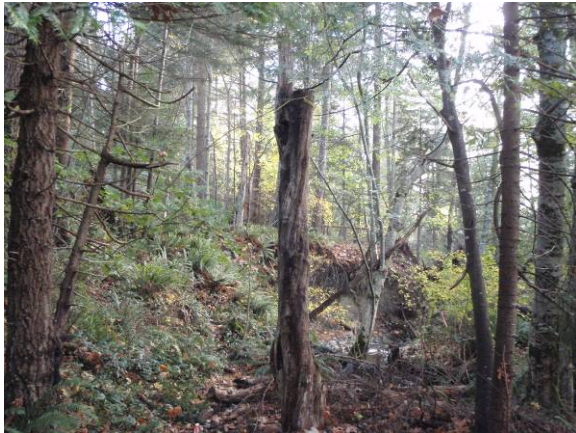
**Photo 6. Wildlife tree installed during decommissioning of temporary tote road (Aug 9, 2010).**

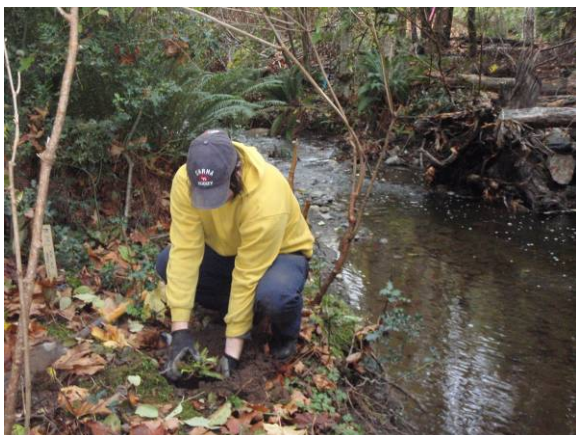
**Photo 7. Planting of rooted native stock completed by CE & BCWS volunteers (Nov 4, 2010).**
