# Overview & Level 1 Fish Habitat Assessment and Enhancement Opportunities

Brooklyn Creek Watershed,  
Comox, BC

Prepared for  
Brooklyn Creek Watershed Society

Final Draft: April 1, 2022

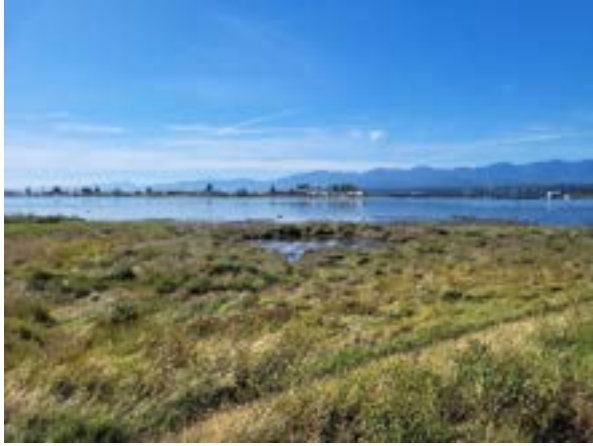
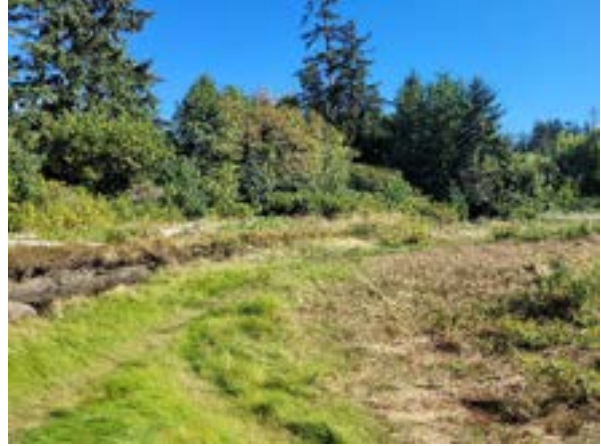
Photos 1 & 2. Low salt marsh through which Brooklyn Creek flows through at downstream end of watershed (above left; Aug. 12, 2021). Low salt marsh to the east of the channel, with depression retaining water shown in centre of photo (above right; Aug. 12, 2021).

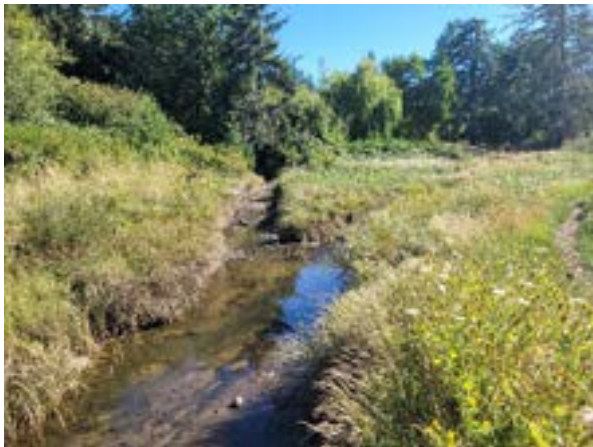
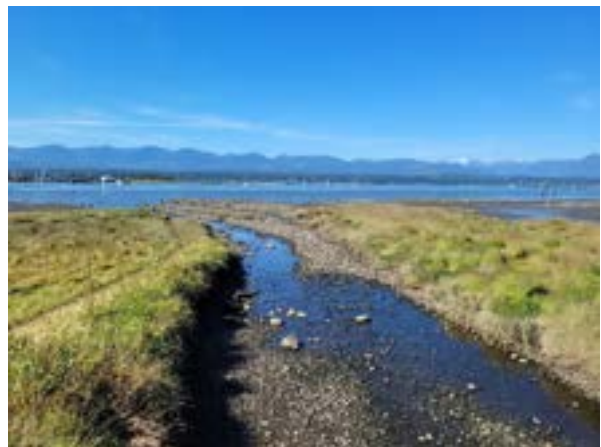
Photos 3 & 4. Looking upstream at confluence between side channel and mainstem from low salt marsh, showing constructed side channel in left side of photo and mainstem in right side of photo (above left; Aug. 12, 2021). Wider channel at seaward edge of low salt marsh, looking toward estuary (above right; Aug. 12, 2021).

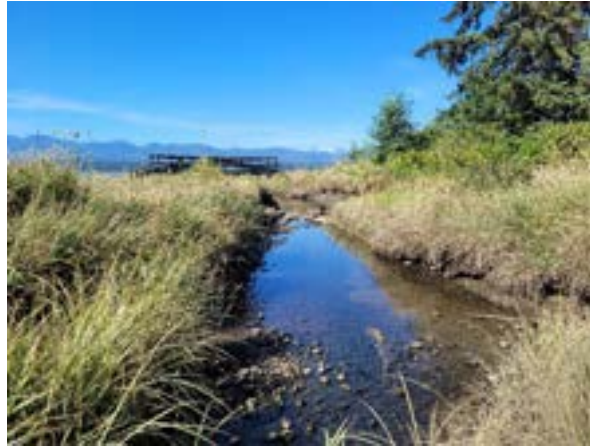
Photo 5. Eroding hardpan banks upstream of walking bridge, looking downstream toward estuary (above left; Aug. 12, 2021).

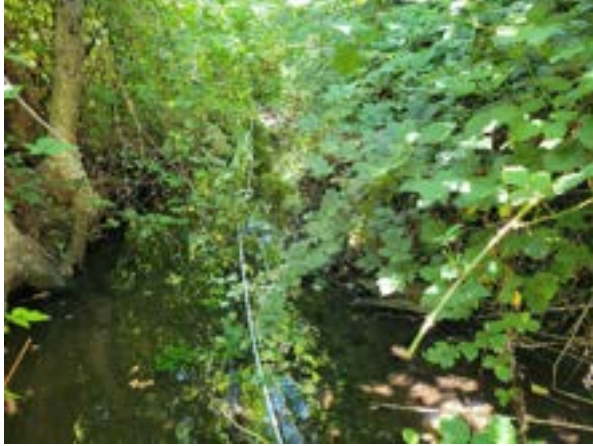
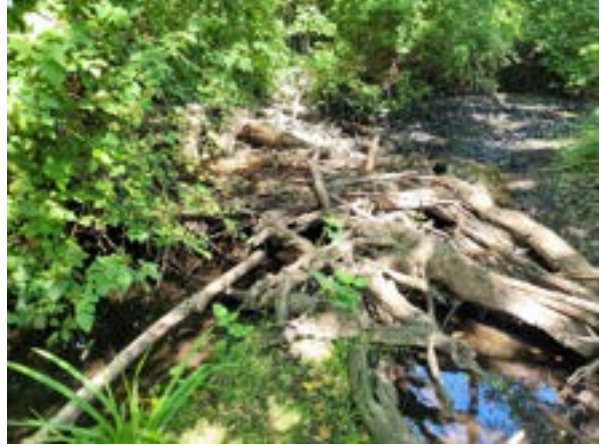
Photos 6 & 7. Pool at approximately km 0+195 (HU P1-1) showing good overhanging vegetation and canopy cover (above left; Aug. 12, 2021). Log jam at approximately km 0+180 (HU G1-1), looking upstream toward riffle (HU R1-1). This log jam does not appear to be a barrier to fish passage (above right; Aug. 12, 2021).

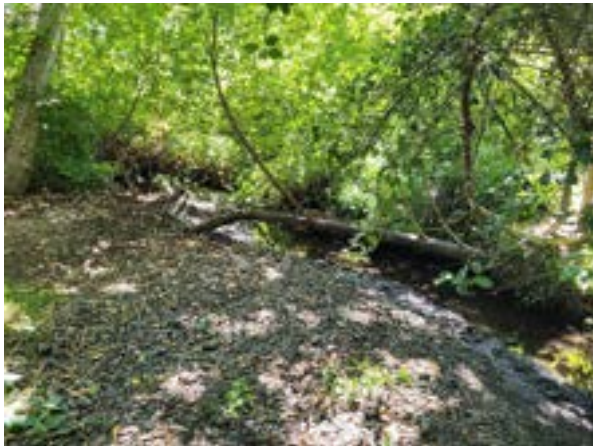
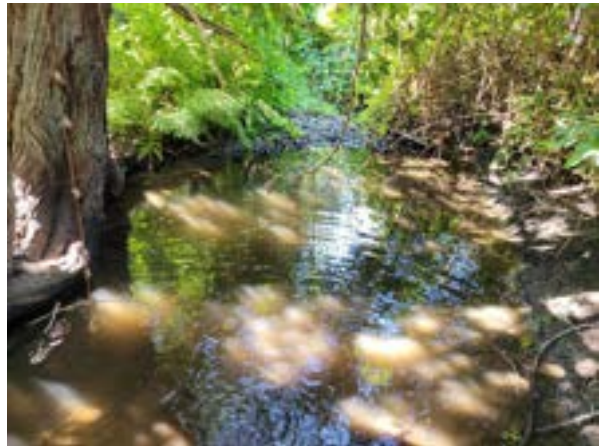
Photos 8 & 9. Undercut banks with exposed roots along right bank in HU G1-1 (km 0+165 to 0+180). Exposed gravel bar along left bank and overhanging invasive English holly (above left; Aug. 12, 2021). Pool at approximately km 0+245 (HU P3-1) providing shaded rearing habitat for salmonids. Himalayan blackberry canes visible in background of photo (above right; Aug. 19, 2021).

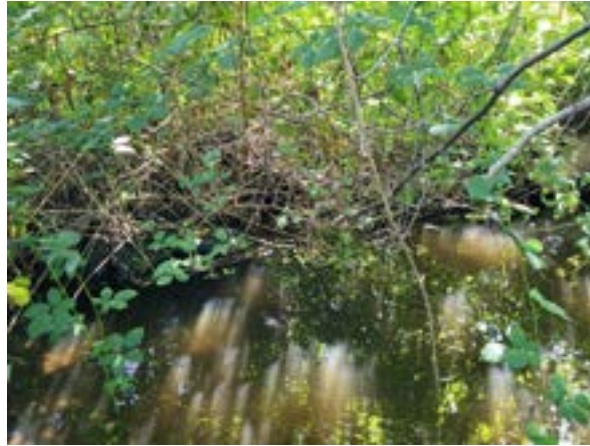
**Photo 10. Installed LWD structure along left bank of pool (HU P2-1; looking downstream), beneath overhanging Himalayan blackberry (above; Aug. 19, 2021).**

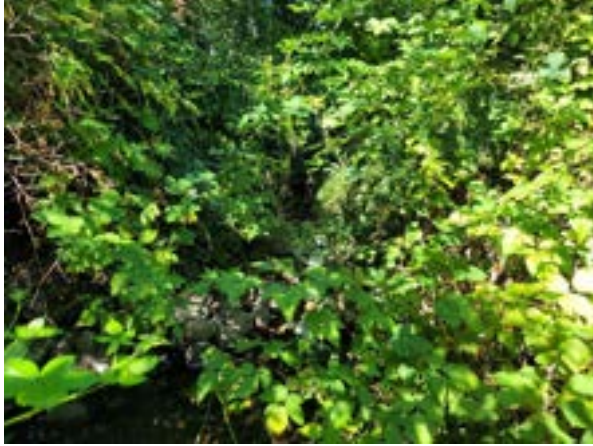
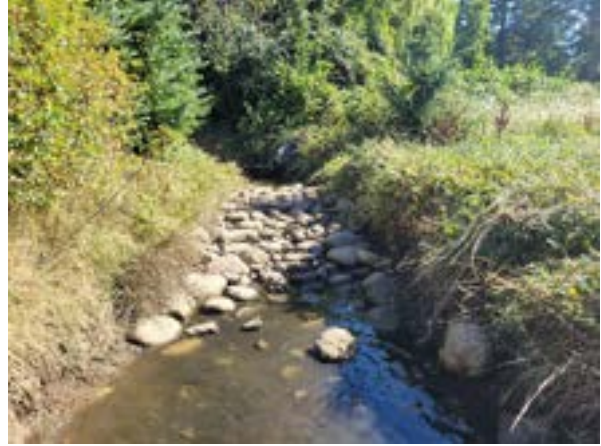
Photos 11 & 12. Upstream end of constructed side channel from mainstem (with invasive species), looking downstream toward side channel. Exposed cobbles at inlet of channel, no surface connectivity at time of site visit (above left; Aug. 12, 2021). Constructed riffle at downstream end of side channel, no scouring at toe of riffle (above right; Aug. 12, 2021).

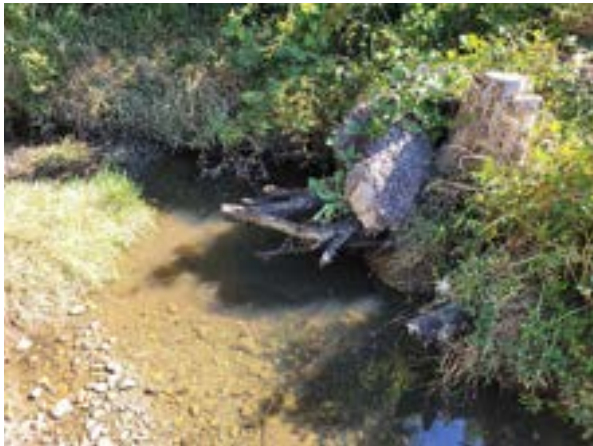
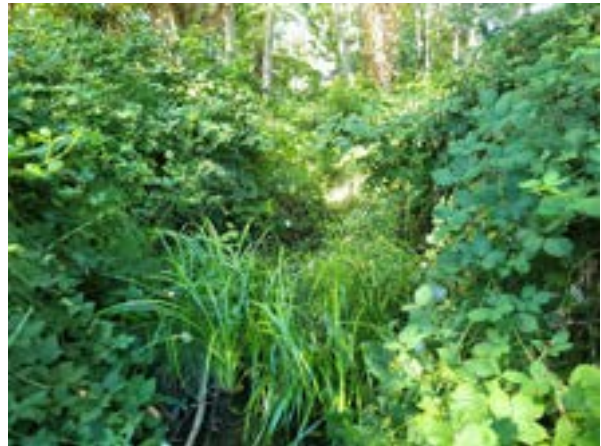
Photos 13 & 14. Installed LWD/boulder complex in pool upstream of constructed riffle in side channel; providing cover and habitat complexity for fish (above left; Aug. 12, 2021). Himalayan blackberry covering banks of side channel, looking upstream (above right; Aug. 12, 2021).

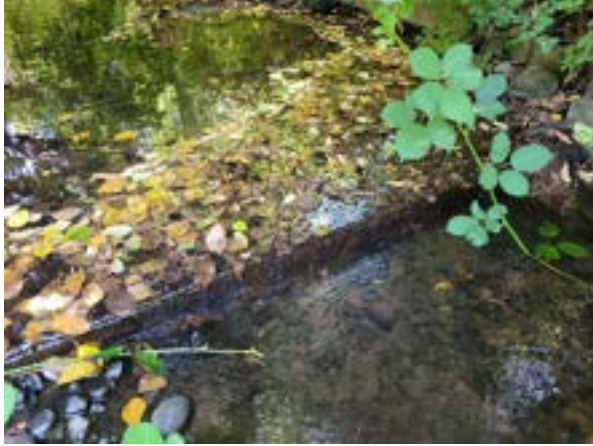
Photos 16 & 17. Fish counting fence at km 0+265; potential barrier to juvenile salmonids during the low flow period (above left; Aug. 19, 2021). Looking downstream toward constructed riffle at approx. km 0+310. Good canopy cover providing shade and litter fall (above right; Aug. 19, 2021).

The fish counting fence immediately upstream of the Baybrook Nature Park bridge may be causing a fish barrier during low flows (Photo 16). A wooden board spans the channel width, creating a 7-8 cm drop at the time of the site visit on August 19<sup>th</sup>, 2021. This should be further assessed during future low flows to determine whether

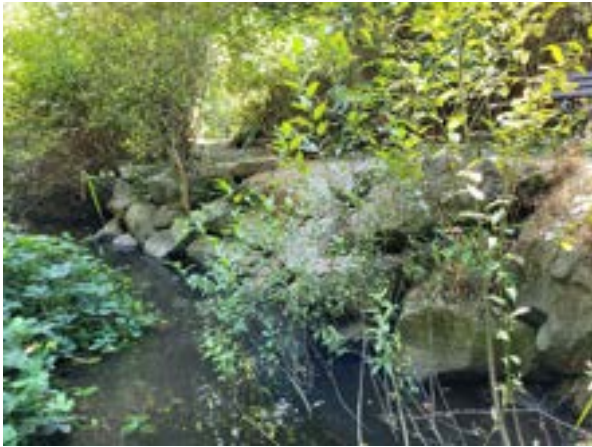
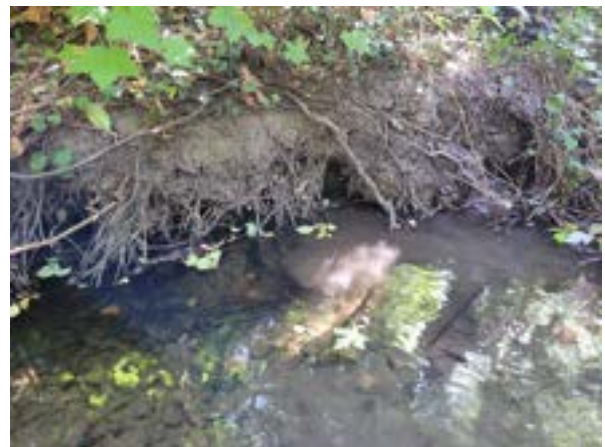
Photos 18 & 19. Pedestrian trail along right bank of Reach 2 at km 0+410; looking downstream at armoured bank (above left; Aug. 19, 2021). Cutbank with exposed roots in HU G1-2 (above right; Aug. 19, 2021).

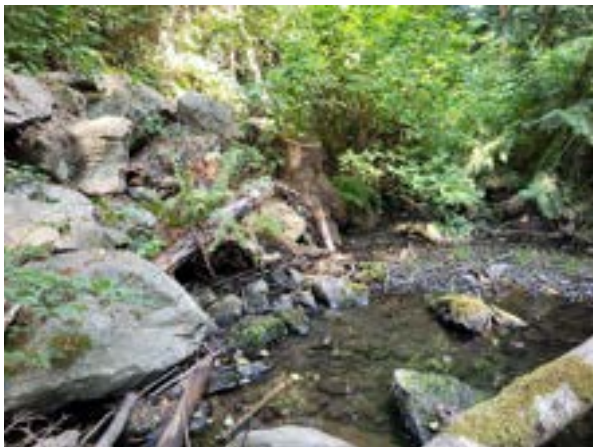
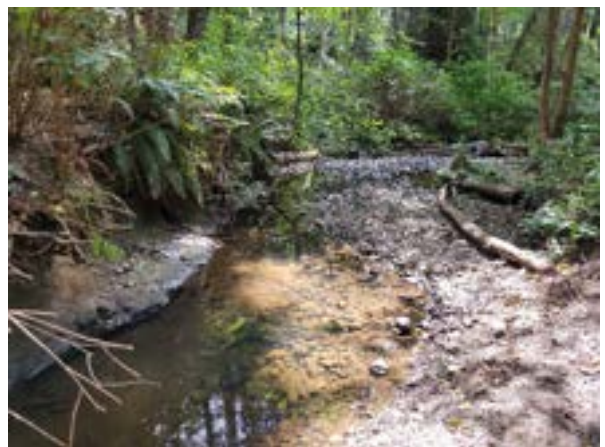
There were many large, exposed gravel bars in this reach (Photo 21), with both cutthroat trout and coho spawning gravel patches observed (Photo 24). The pool habitats appear to be functioning well in this

Photos 20 & 21. Armoured bank with riprap to prevent further erosion in HU G2-2 (km 0+660; above left; Aug. 20, 2021). Eroded hardpan along right bank in HU G3-2 resulting in cutbanks at higher flows (above right; Aug. 20, 2021).

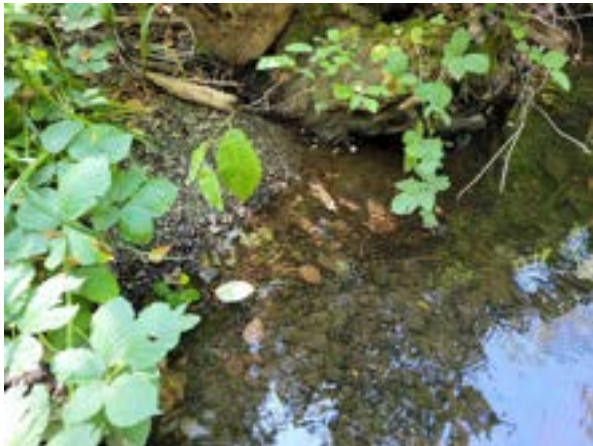
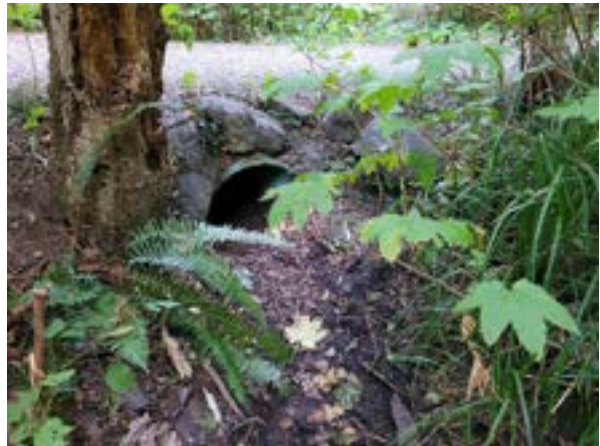
Photos 24 & 25. Spawning gravels along bank in HU P1-2 at km 0+385 (above left; Aug. 19, 2021). Culvert beneath walking path connecting wetted area to the west and Brooklyn Creek during high flow events (above right; Aug. 20, 2021).

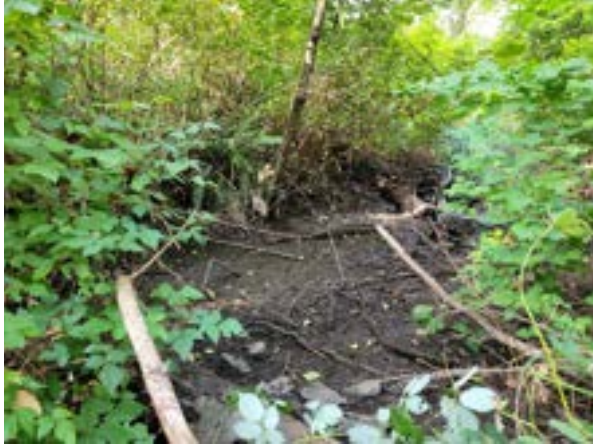
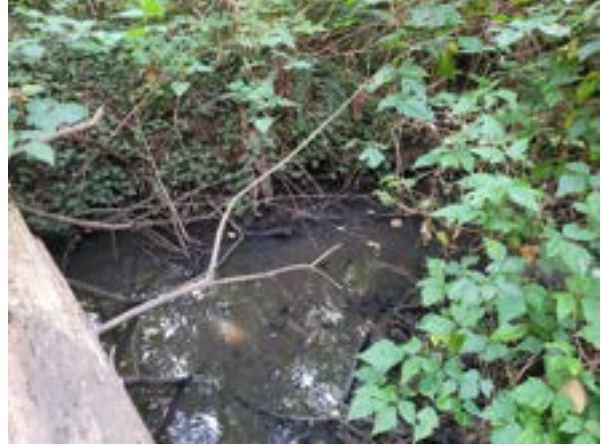
1. There is a historical side channel along the right bank of Reach 2, between approximately km 0+418 and km 0+435. The upstream end of the channel is indistinct and was dry at the time of the assessment, therefore the mapping for this channel is approximate. The upstream end of the channel has infilled with vegetation (predominantly salmonberry), with bigleaf maple, hemlock, and red alder providing cover and shade. Several pieces of LWD have been deposited across the old channel. The banks are somewhat visible but are not clearly defined at the upstream end, however, the downstream end of the channel has clearly eroded and defined banks, alluvium, and standing water (Photos 28 and 29). The eroded banks suggest that the side channel has received flows from the mainstem during winter months, however, due to the deep and muddy fines in the downstream end and the presence of terrestrial vegetation in the upstream end, it appears that the channel is no longer connected to the mainstem and likely never provides summer rearing habitat for fish. This historical side channel may provide habitat during extreme high flows.

Photos 28 & 29. Dry side channel between km 0+418 and km 0+435 with defined banks and deep and muddy substrates (above left; Aug. 20, 2021). Standing water in a section of the dry side channel (above right; Aug. 20, 2021).

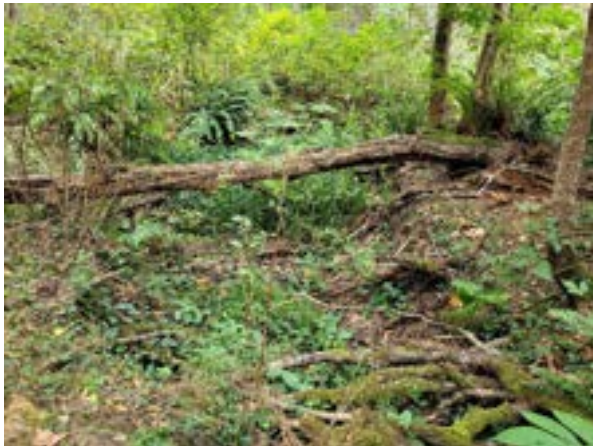
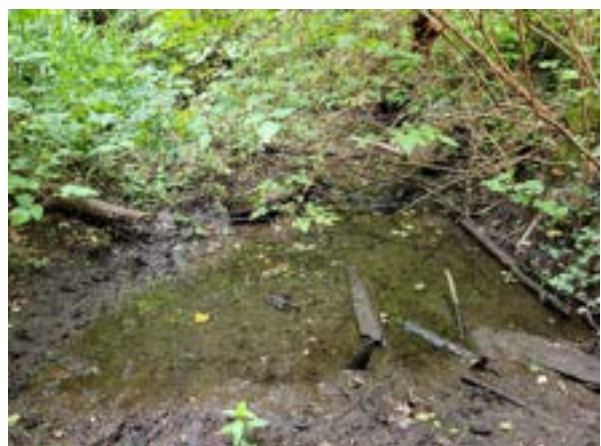
2. There is a second historical side channel along the left bank of Reach 2, between approximately km 0+615 to 0+690. This channel was dry at the time of the site assessment and does not appear to have had flow recently, however the banks are distinct in several locations (mainly near the upstream end) and there is evidence of alluvium and rafted debris within the old channel (Photo 30); it is likely that this channel was once connected to the mainstem during the

Photos 30 & 31. Dry side channel between km 0+615 to 0+690 with defined banks and rafted debris (above left; Aug. 20, 2021). Isolated pool adjacent to left bank of mainstem at km 0+635 (above right; Aug. 20, 2021).

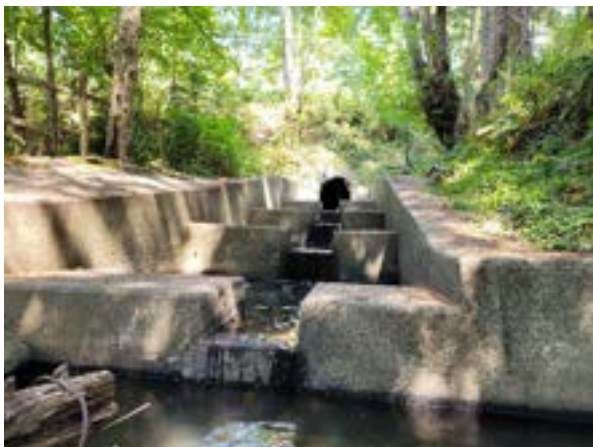
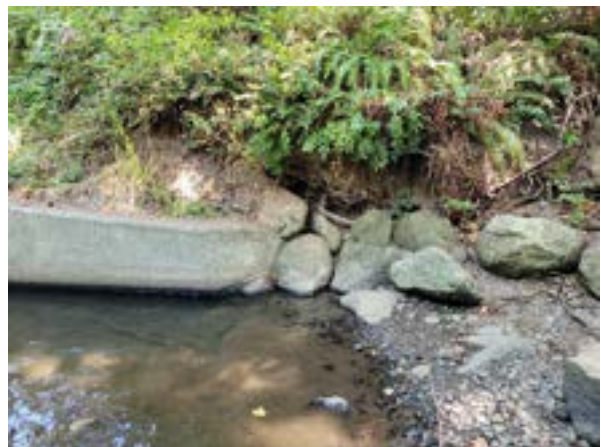
The Balmoral Avenue fish ladder is located at the upstream end of the reach, and has the potential to be a low flow barrier for juvenile salmonids during the summer months (Photo 32). The native base of the ladder has eroded over recent years and water can be typically observed seeping under the structure when base flows are insufficient for surcharging one or more of the ladder cells. Surface flow disconnection at the ladder may be impairing juvenile fish passage and nutrient supply. Corrective measures have been implemented by the Town of Comox in the past by re-nourishing the bed of the ladder with a mix of aggregates, however erosive energy from heavy flows continue to pose maintenance challenges. The Town of Comox will be exploring options to restore the ladder, which may involve sealing the base of each cell with concrete. Obstructions, such as dams and in-stream structures can cause fish passage issues, resulting in fewer rearing habitats for salmonids during the low flow summer months (Government of Canada 2010). Water was flowing around the left bank of the structure (Photo 33) instead of outletting at the bottom step of the ladder during the assessment on August 19<sup>th</sup>, 2021. The outlet drop was 17.6 cm, the outlet pool depth was 54.0 cm and the maximum pool depth beneath the fish ladder was 89.6 cm. This means that the outlet drop is 33% of the pool depth immediately downstream of the fish ladder outlet.

Photos 32 & 33. Fish ladder downstream of Balmoral Avenue potentially acting as fish barrier during low flows (above left; Aug. 20, 2021). Water flowing around left bank of fish ladder instead of all through centre of fish ladder downstream of Balmoral Avenue (above right; Aug. 20, 2021).

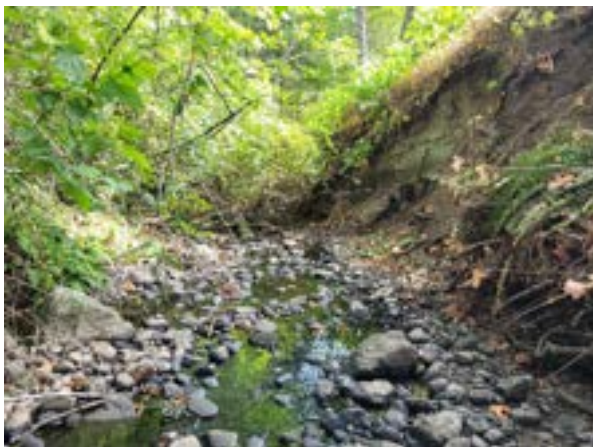
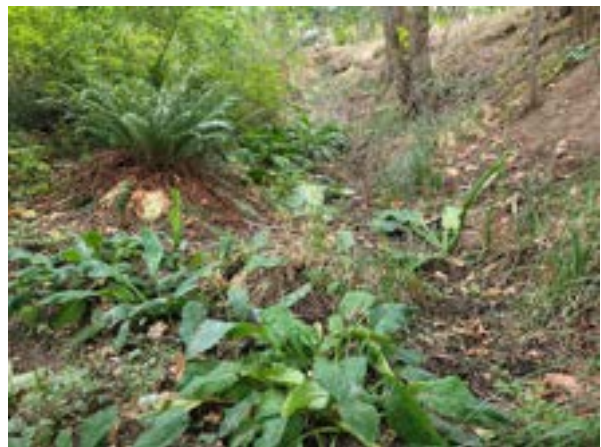
Photos 39 & 40. Steep and eroded bank in Reach 3 (above left; Aug. 25, 2021). Off-channel pond at km 1+555 that appears to hold water during high flow winter months; filled with slough sedge and skunk cabbage (above right; Aug. 25, 2021).

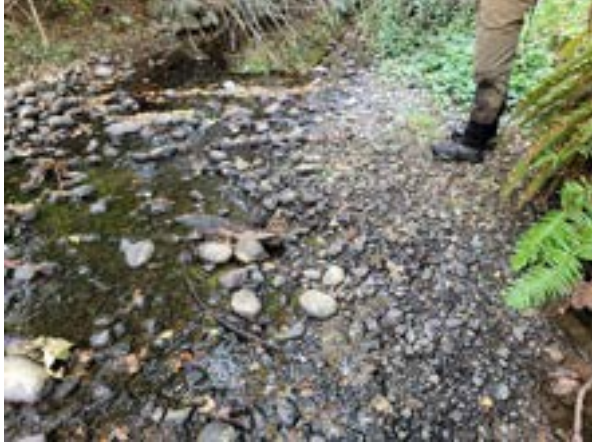
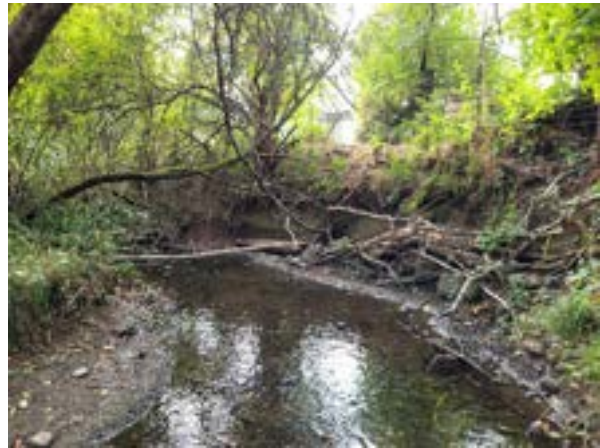
Photos 47 & 48. Small gravel bar along left bank at km 1+570 (in HU G3-3; above left; Aug. 25, 2021). Fencing and bank revetments along right bank in HU G3-3 (above right; Aug. 25, 2021).

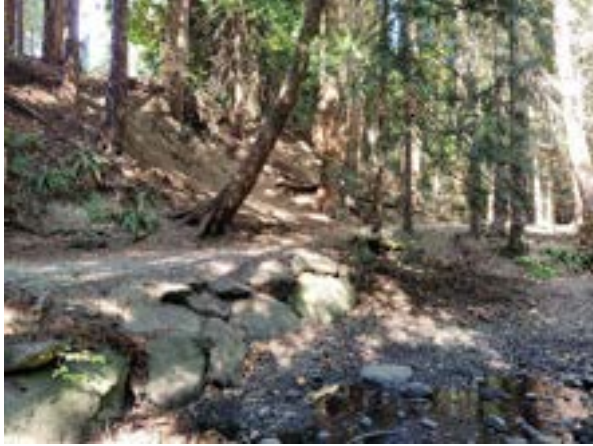
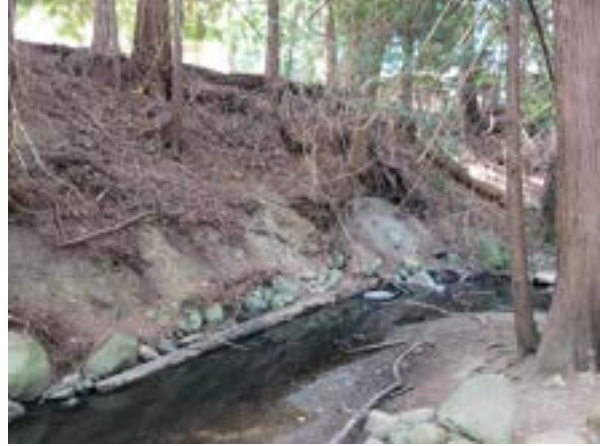
**Photos 53 & 54. Steep ravine bank along right bank of stream between approximately km 1+037 and 1+052 that could use terraces and planting to stabilize slope and provide cover/shade to stream (above left; Aug. 25, 2021). Steep right bank at km 1+105 that could use terraces and planting to stabilize slope and provide cover/shade to stream (above right; Aug. 25, 2021).**

- 4) The right bank at km 1+105, immediately upstream of the walking bridge is very steep and is lacking understory species (Photo 54). Small terraces could be constructed along the slope with horizontal wood ledges/walls to create flat zones for planting. Native topsoil should be added to these terraces and they should be planted with native species that can tolerate full shade conditions such as sword fern, lady fern, dull-oregon grape, salmonberry, snowberry, Pacific ninebark, Western red cedar, Douglas fir, and Bigleaf maple. This would minimize erosion and would provide wildlife habitat and shading/litter drop opportunities to the stream. The left bank along this section of stream is severely compacted and denuded and requires decompaction, native species planting, the addition of woody debris, and split rail fencing to prevent pedestrians from accessing the stream in this location.

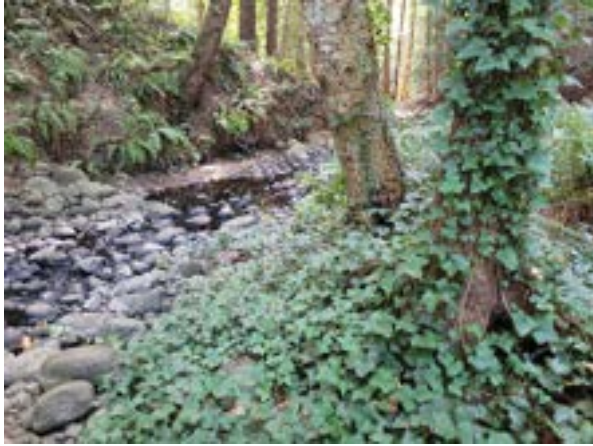
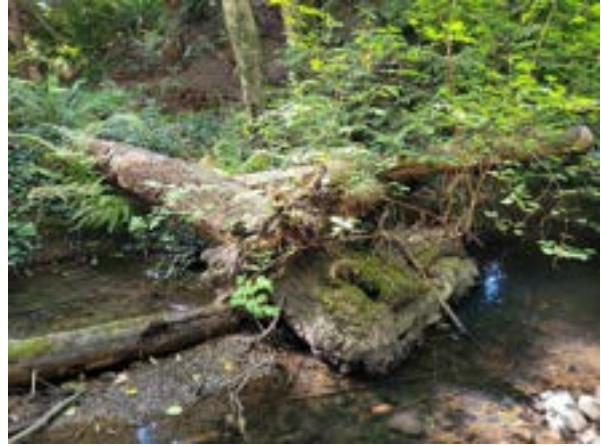
Photos 57 & 58. Dense English ivy along left bank at km 1+132 (CR3.6; above left; Aug. 25, 2021). Dense English ivy along right bank at km 1+150 (above right; Aug. 25, 2021).

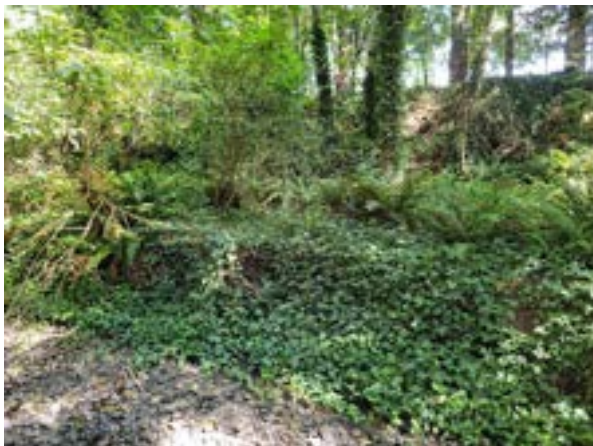
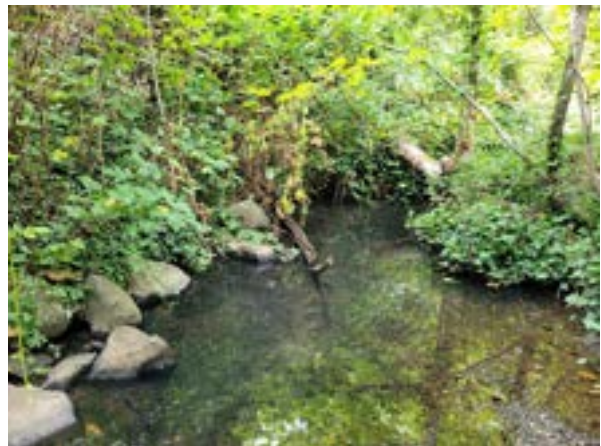
Photos 59 & 60. Dense English ivy along right bank at km 1+223 (above left; Aug. 25, 2021). English ivy and Himalayan blackberry along both banks between km 1+260 – 1+290 (above right; Aug. 25, 2021).

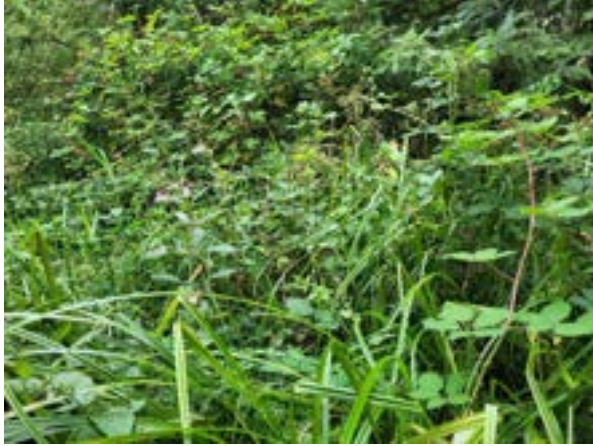
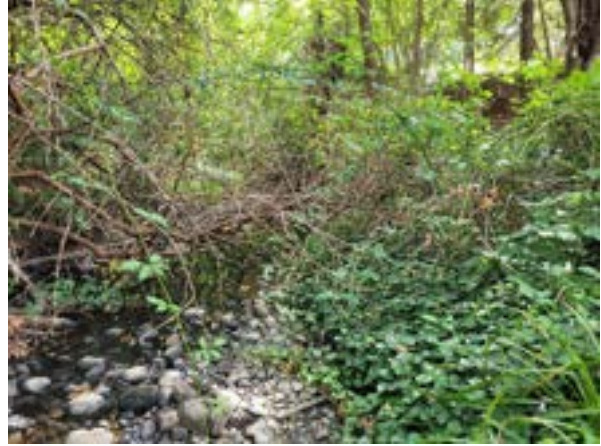
Photos 61 & 62. Policeman's helmet and Himalayan blackberry along left bank at km 1+490 (above left; Aug. 25, 2021). English ivy and Himalayan blackberry along both banks between km 1+525– 1+550 (above right; Aug. 25, 2021).

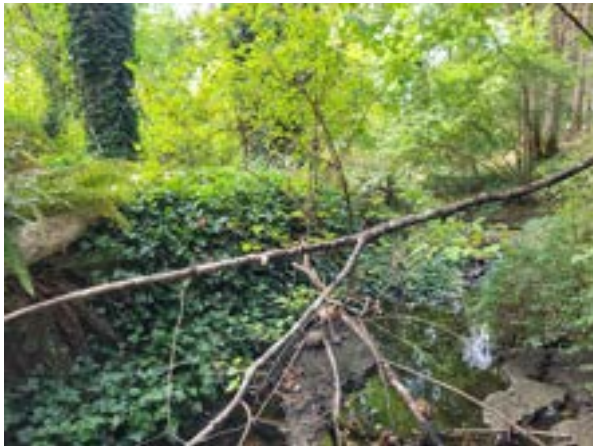
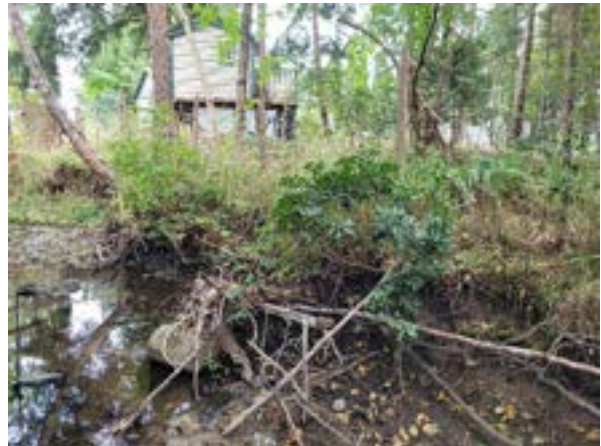
Photos 63 & 64. Dense English ivy along left bank at km 1+685 (above left; Aug. 25, 2021). Spurge laurel and English holly along left bank at km 1+805 (above right; Aug. 25, 2021).

11) km 1+685 – English ivy should be removed from left bank (Photo 63).

12) km 1+805 – Spurge laurel and English holly should be removed from both banks (Photo 64).

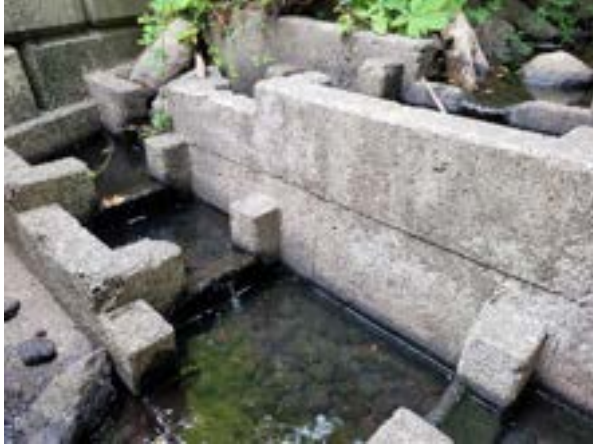
Reach 4 extends between Dogwood Road and Noel Avenue, for a distance of 235 km. There is a constructed fish ladder upstream of the culvert at Dogwood Avenue which may be acting as a barrier under some flow conditions (Photo 65). The outlet drops were often greater than 50% of the depth of the pools beneath each of the steps during the August 26<sup>th</sup> site visit. Further assessments will be done of this fish ladder to determine if it is causing fish passage issues during low flows.

Photos 65 & 66. Constructed fish ladder upstream of Dogwood Avenue acting as low flow barrier to salmonids (above left; Aug. 26, 2021). Pedestrian bridge at km 1+970 in Reach 4; pedestrian path along right bank in this section of Reach 4 (above right; Aug. 26, 2021).

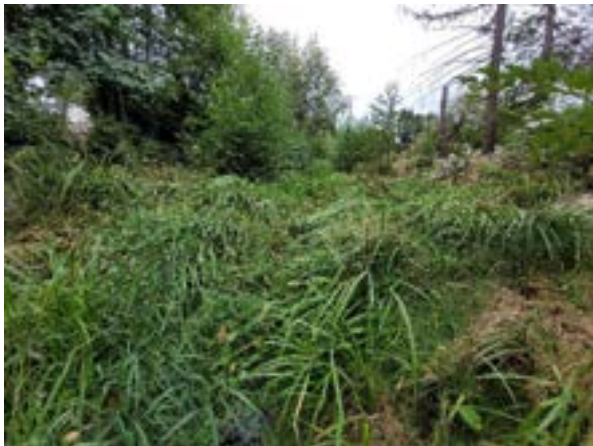
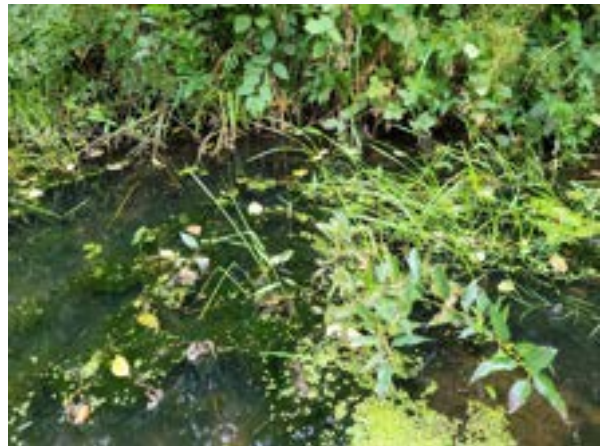
The section between the walking bridge and Noel Avenue is also straightened and dredged, however it was filled with in-stream vegetation at the time of the site assessment on August 26<sup>th</sup>, 2021 (Photo 67). Vegetation within the channel included small-flowering bullrush, willow species, sedge species, cattails, and duckweed. Large mats of green algae were also observed on the water's surface in this section of the reach during the August 26<sup>th</sup> site visit (Photo 68). Riparian vegetation along the left bank of this section of Reach 4 were planted in 2015 and included red alder, bitter cherry and willow species (Photo 69). Invasive Himalayan blackberry was growing along the left bank of the channel. The right bank of this section of the reach is armoured with small riprap, since a residential building is immediately adjacent to the creek (Photo 69). Several drainage pipes were observed outletting into the right bank of Reach 4.

Photos 67 & 68. Straightened channel between pedestrian bridge and Noel Avenue filled with in-stream vegetation (above left; Aug. 26, 2021). Green algae mats and duckweed on the surface of the channel between the pedestrian bridge and Noel Avenue (above right; Aug. 26, 2021).

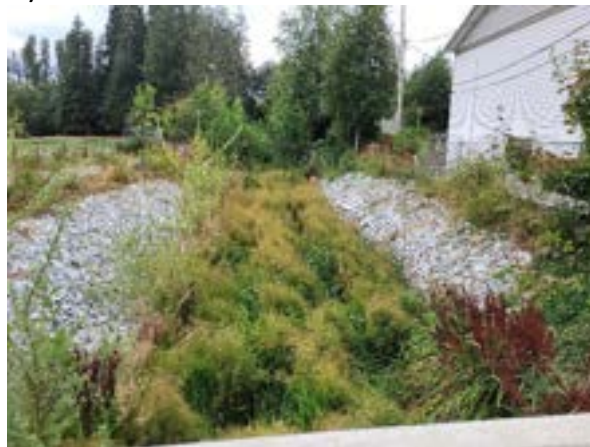
Photos 69. Planted riparian vegetation along left bank of Reach 4, immediately downstream of Noel Avenue channel in-filled with vegetation (above; Aug. 26, 2021).

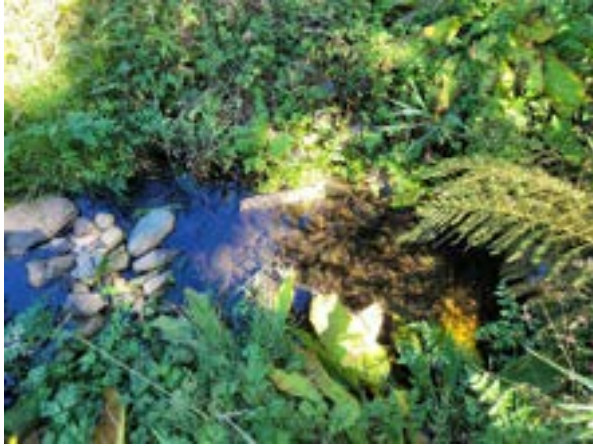
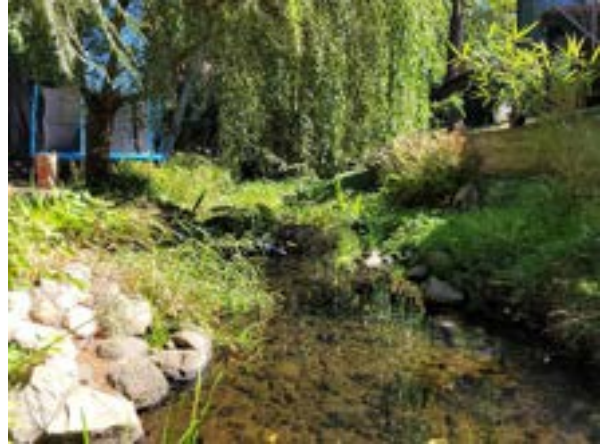
Photos 72 & 73. CR4.1 Skunk cabbage, small-flowering bullrush, and water parsley along banks of HU G1-5 (above left; Sept. 2021) Residential development right to streams edge on both right and left banks in HU G1-5; looking downstream. Rip-rap armoured wall along left bank and retaining wall with planted bamboo along right bank (above right; Sept. 2021).

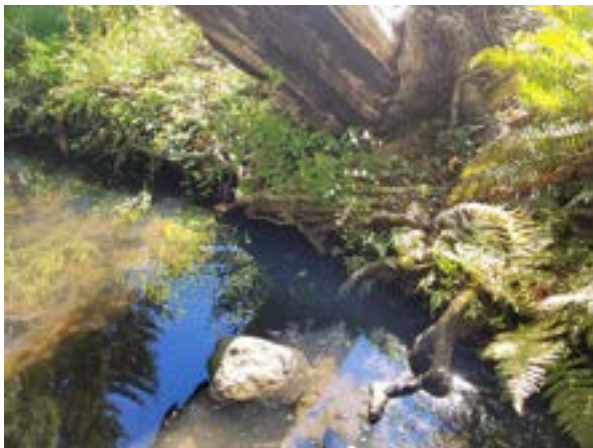
Photos 74 & 75. Cutbanks with exposed roots along right bank in HU G1-5 indicating high flows causing erosion during the winter months (above left; Sept. 2021). Looking downstream of HU G1-5 at bridge constructed over channel; skunk cabbage and water parsley in channel (above right; Sept. 2021).

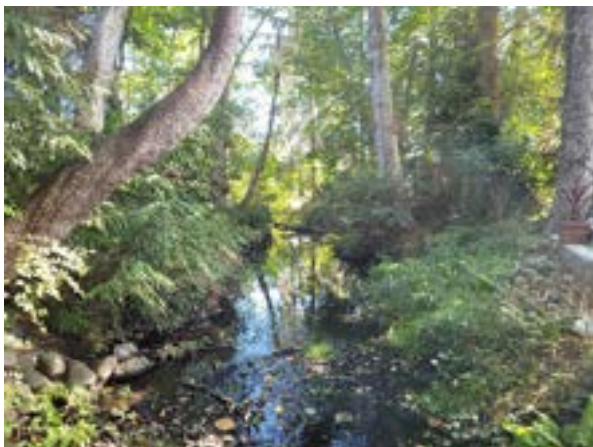
Photos 76 & 77. Cutbanks with exposed roots along right bank in HU G1-5 indicating high flows causing erosion during the winter months (above left; Sept. 2, 2021). Good riparian cover in section of Reach 5 in Salish Park (above right; Sept. 2021).

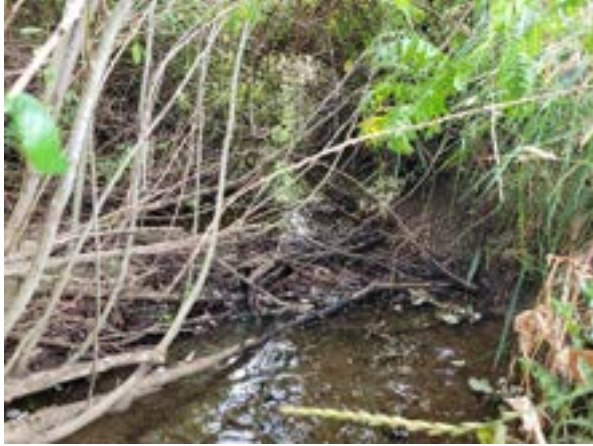
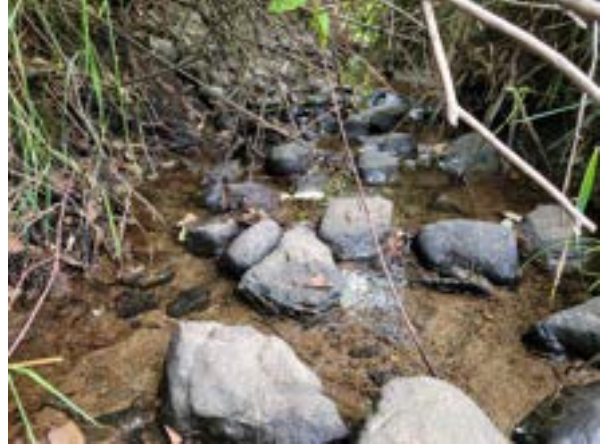
Photos 82 & 83. Approx. km 3+700; substrates are primarily composed of fines, banks are eroded, and shrubs are providing overhanging vegetation (above left; Aug. 26, 2021). Cobble, boulders, and gravel riffle in HU G1-6 at approximately km 3+690 (above right; Aug. 26, 2021).

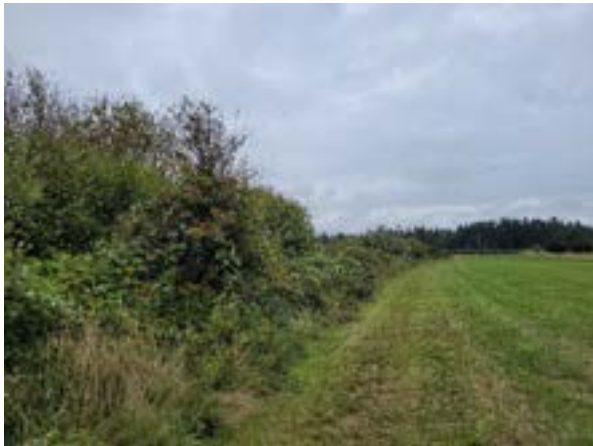
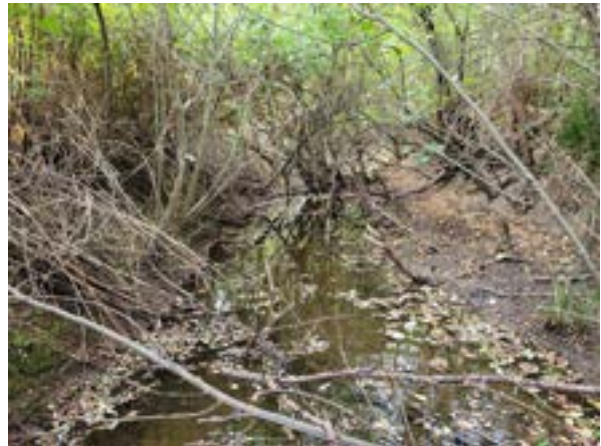
Photos 84 & 85. Narrow riparian strip primarily composed of red alders, willows, and understory shrubs (above left; Aug. 26, 2021). Looking downstream in wider section of stream in southeastern portion of Reach 6 (HU G2-6; at approximately km 3+260); composed of fine substrates. Stream is covered with dense overhanging vegetation (above right; Aug. 26, 2021).

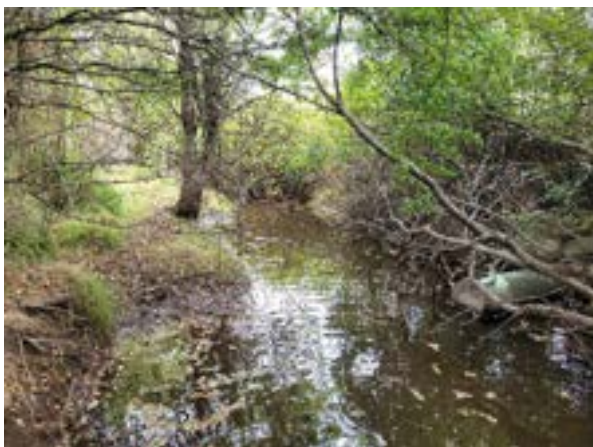
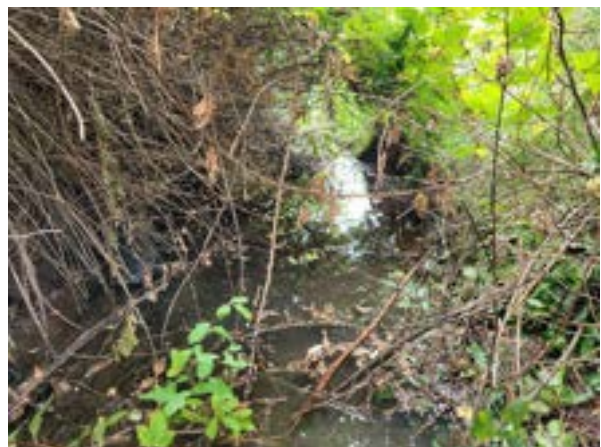
Photos 86 & 87. Covered pipe extending into left bank of G2-6 (km 3+260; above left; Aug. 26, 2021). Narrower channel in HU G6-1 (at approximately km 3+670) with substrates primarily composed of fines and gravels (above right; Aug. 26, 2021).

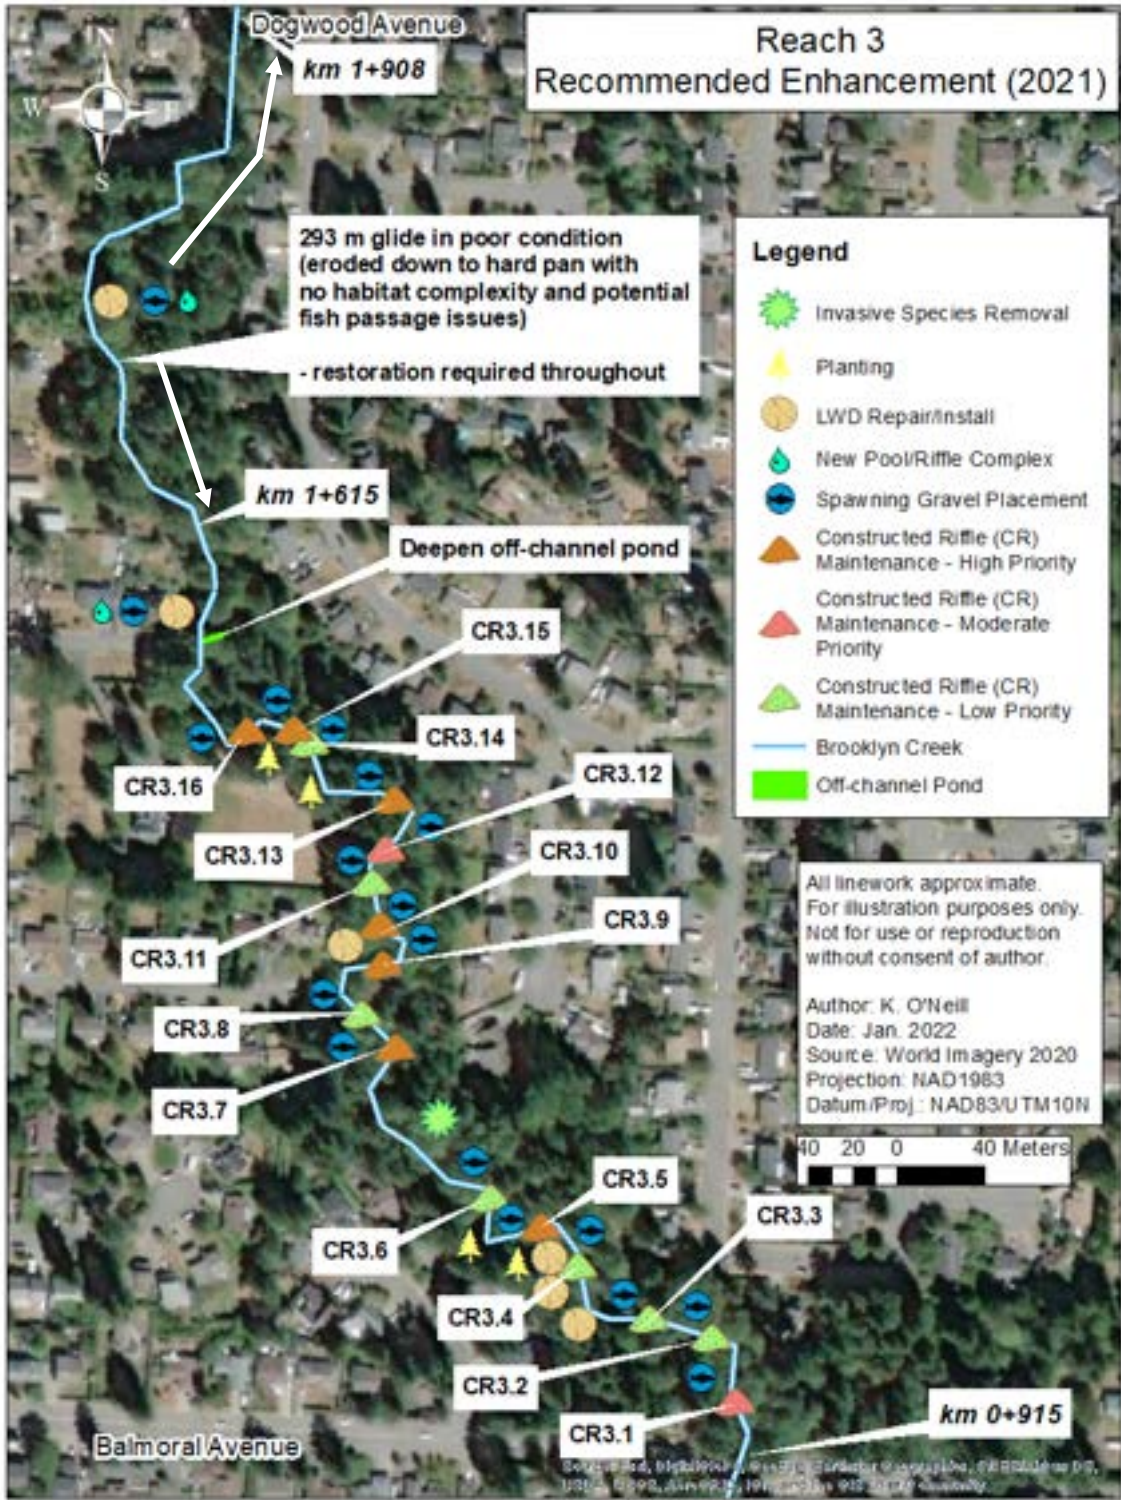
Figure 16. Reach 3 overview showing general locations of recommended enhancement projects. Invasive species removal should be conducted throughout reach (especially in areas where other enhancement/maintenance work is conducted) – invasive species removal symbol symbolizes entire reach.
